DDAS Accident Report

Report date: 19/05/2006	Accident number: 390
Accident time: 06:00	Accident Date: 11/07/2003
Where it occurred: MF 324 (NDO 253) at Nabatieh	Country: Lebanon
Primary cause: Unavoidable (?)	Secondary cause: Inadequate equipment (?)
Class: Vegetation removal accident	Date of main report: [not recorded]
ID original source: IAB	Name of source: NDO Lebanon
Organisation: Name removed	
Mine/device: Fuze	Ground condition: grass/grazing area
Date record created: 22/02/2004	Date last modified: 22/02/2004
No of victims: 1	No of documents: 2

REPORT FOR ACCIDENT INVESTIGATION BOARD OF INQUIRY

Demining Accident that occurred in MF 324 (NDO 253) on 11 of July 2003 in which [Demining group] DEMINER [The Victim] was injured.

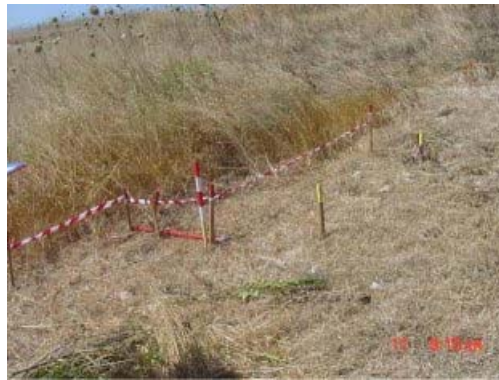
VIEW OF THE ACCIDENT SCENE

There had been an uncontrolled surface detonation of a detonator. Probably it's a Gyata-64 detonator booster.

[The Victim] 's scissor had been in direct contact with the detonator booster at the time of detonation.

The vegetation in the minefield is very thick and this makes the visual inspection more difficult.

[The original report indicated that the detonation occurred in front of the base stick in the "cleared" area.]

The primary cause of this incident is listed as "Unavoidable" because it is not at all clear what the Victim initiated with his vegetation cutting shears. The photographs indicate that the detonation occurred behind the Victim's end-of-lane marking stick. It is not normal to move the stick forward before cutting the undergrowth and clearing the area with a metal-detector or excavation, so the device may have actually been "missed".

As in this case of thick vegetation and to prevent accidents, the National TSGs allows burning the vegetation (Chapter 4, Para. 4.21), so we recommend using this method if it's suitable to be used (Supervisor decision).
